# Department for Environment and Heritage

## Maintenance and Repair of Older Buildings in South Australia

### Technical Note 3.1

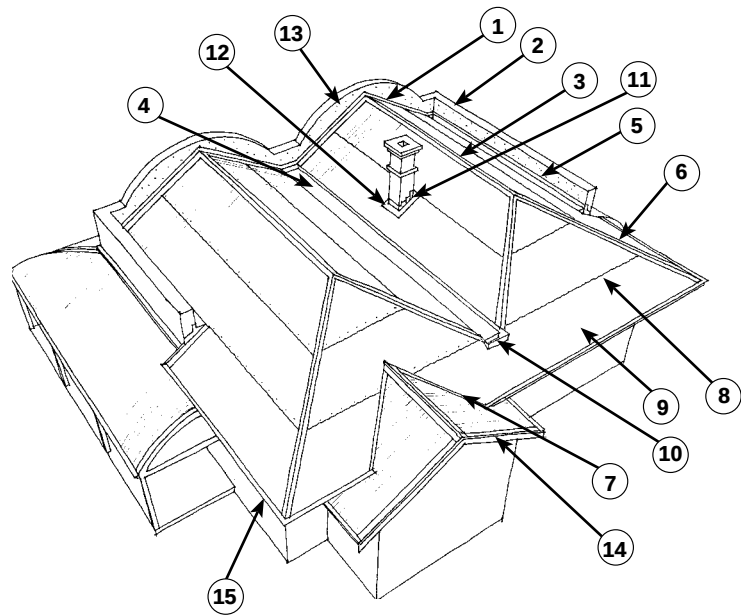
#### Typical Roof Anatomy

1. Parapet Flashing
2. Parapet Coping
3. Ridge Cap
4. Box Gutter
5. Flashing
6. Hip Capping
7. Valley Gutter
8. Sheet Laps
9. Corrugated sheet metal Roof Sheets
10. Rainwater Head
11. Stepped Chimney Flashing
12. Chimney Soaker Tray
13. Rendered Coping
14. Barge Capping
15. Eaves Gutter

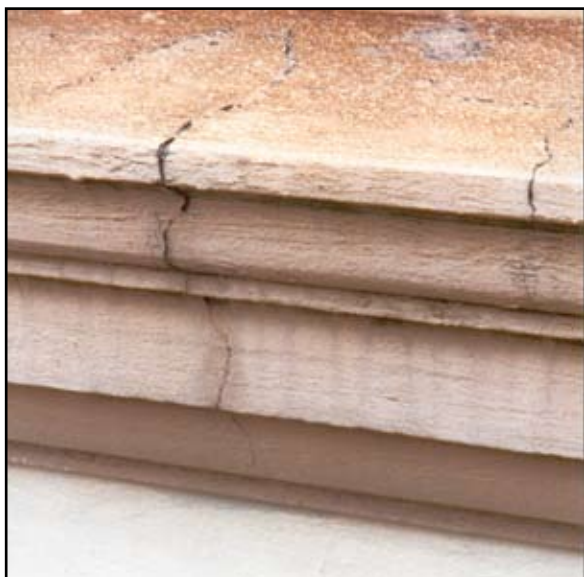
These fine cracks are sufficient to allow in water and eventually lead to the structural failure of this decorative cornice.

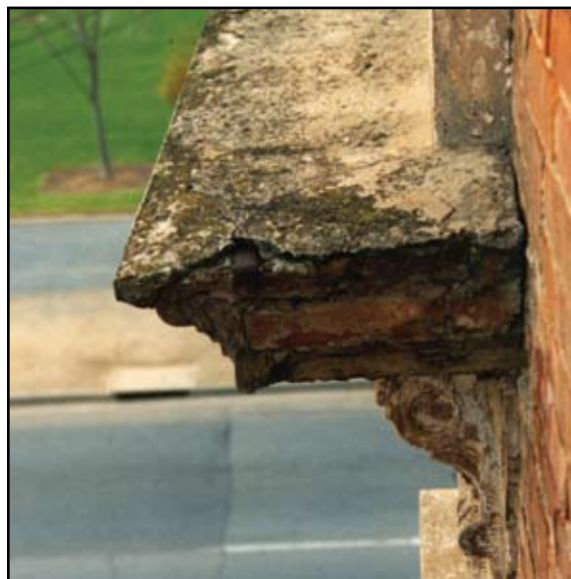
Lack of maintenance on top surface of cornice has allowed water to seep in and damage the moulding.

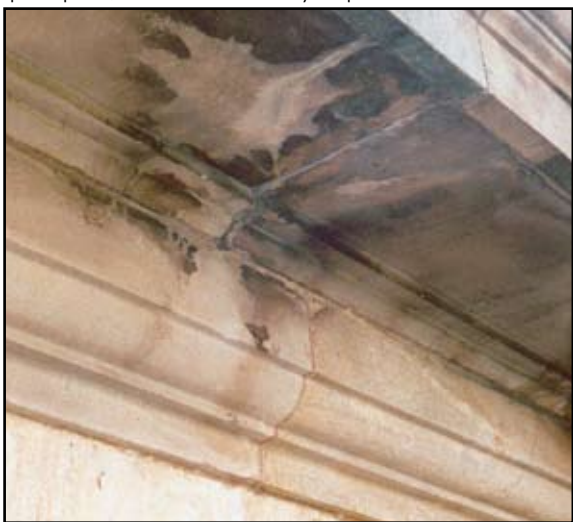
Mortar has been eroded from the joints in this stone cornice by the penetration of moisture through the top surface. Failure to repoint the joints has caused considerable damage to the stone either side of the joints. The damage is a form of salt attack due to air movement through the open joints in the presence of salts (from bird droppings for instance)

that the mortar between individual pieces of stone, particularly the vertical mortar joints, is intact. Even minor cracking or a small loss of mortar between the stones can result in rainwater penetrating into the masonry and causing delamination (deterioration of successive layers) of the stonework and structural weakening of the wall.

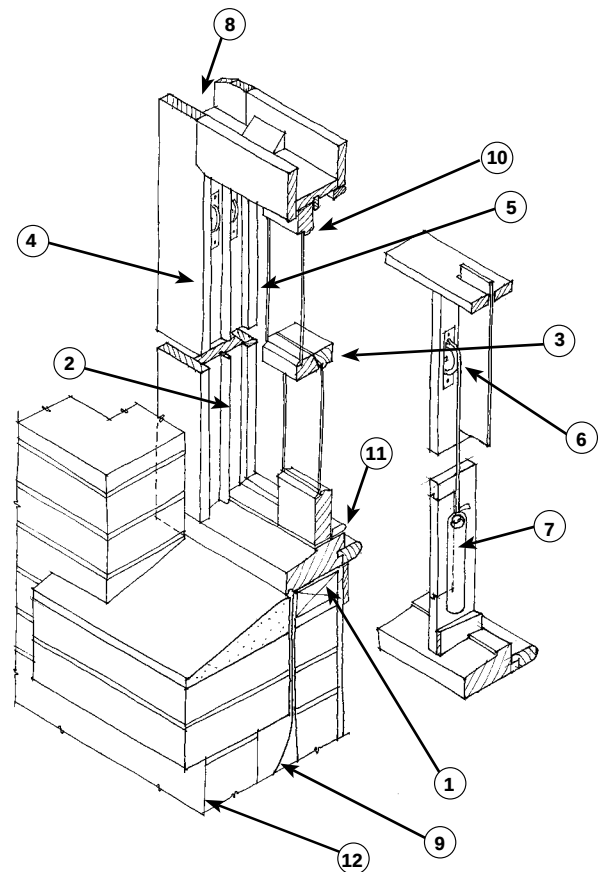
Typical timber double hung sash window - Portion of frame cutaway view

The majority of historic buildings have timber windows. The most common types are the casement (side-hinged) and the double-hung window (vertically-sliding sashes with concealed counterweights). Properly maintained, timber windows have an indefinite life, but are susceptible to rapid decay if not adequately protected from moisture.

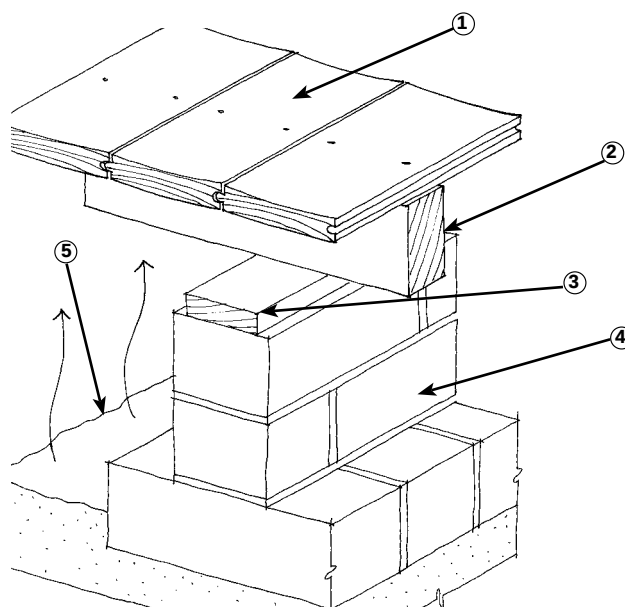
Cupped Floor Boards

1. Tongue and Grooved Boards
2. Hardwood Joist
3. Plate
4. Dwarf Wall
5. Soil Moisture Humidifies Sub-floor

The floor should not be sanded to achieve a more level surface. This will permanently damage the floor because the sanding machine will attack the raised edges of the boards and remove considerable material before it reaches the central section of the board. Once the tongue and groove joint is weakened and starts to split away, the floor is damaged beyond repair.

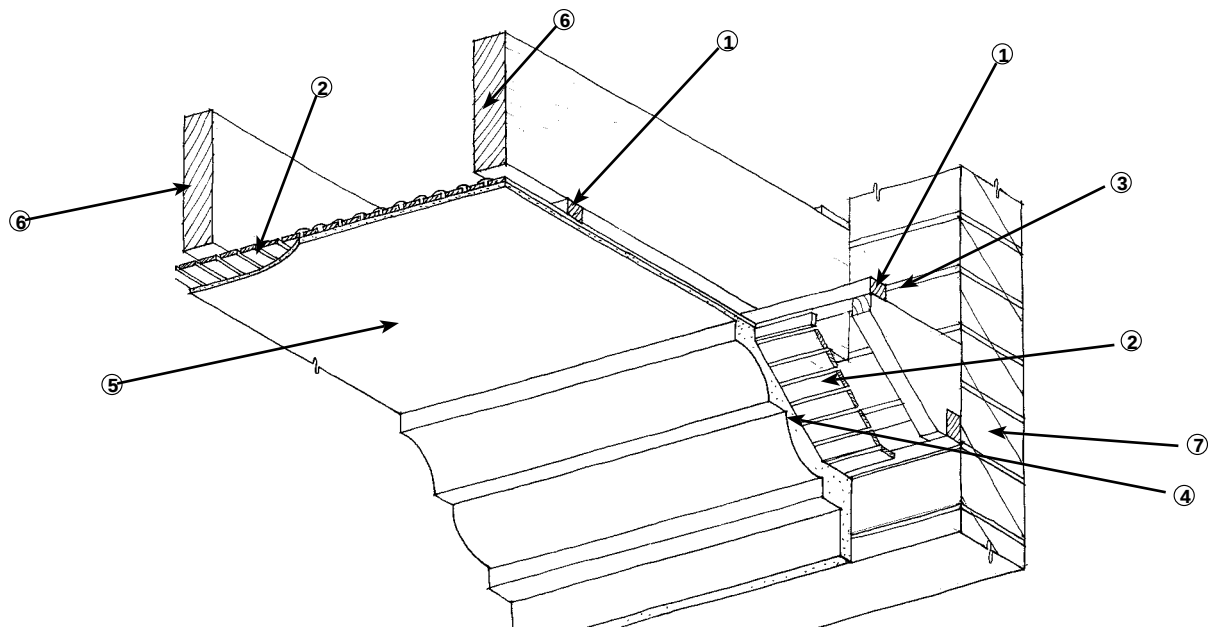
Typical Lath & Plaster Ceiling with Ornate Cornice

1. Hardwood Brackets  
(Battens) 350c/c Max  
2. Split Hardwood Laths

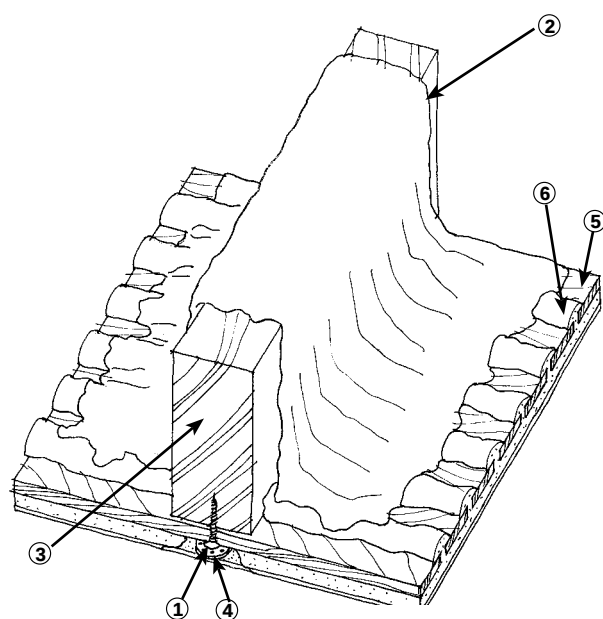
Ceiling Stabilisation screwed and looped method

1. Screw with washer fixing from beneath
2. Fibres set in plaster or acrylic resin
3. Ceiling joists – 350 max
4. Laths resecured to ceiling joists using brass screws with

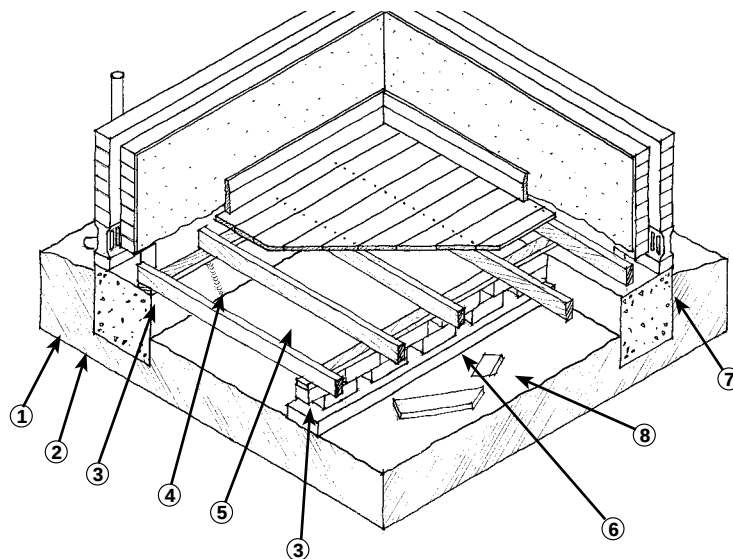
#### Potential Subfloor problems

1. Dampness in subfloor area from downpipes or leaking plumbing
2. Water ponding near wall, or entering through subfloor vents due to raised paving or ground levels
3. Absence of ant caps or damp proof membrane between timber floor plates and masonry dwarf walls
4. Termite tunnels giving access to timbers
5. Insufficient clearance between soil level and floor joists
6. Damaged or unstable dwarf walls
7. No damp proof course in external walls, or damp proof course damaged or bridged by repointing
8. Termites attracted by scraps of timber left on ground

- **excessive air humidity** - leading to cupping of the floor boards (curling up at the joints) as the under-surface expands
- **excessive moisture** in walls and dwarf walls - promoting rising damp and salt attack

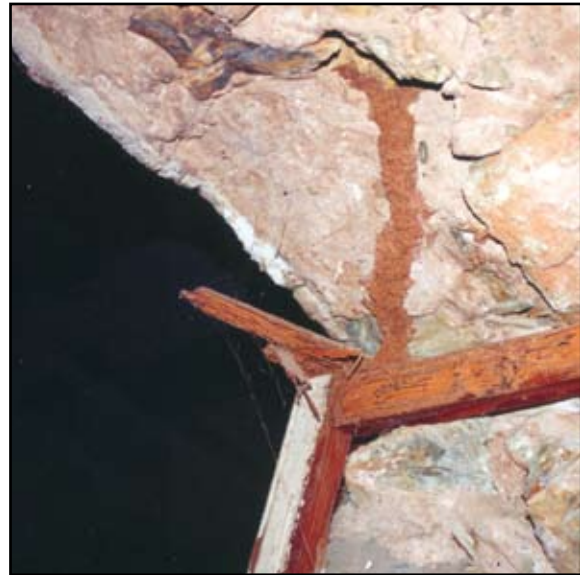
The door frame, lining and structural timber lintel of this doorway have been completely eaten by termites. A mud gallery is clearly visible at the centre of the picture.

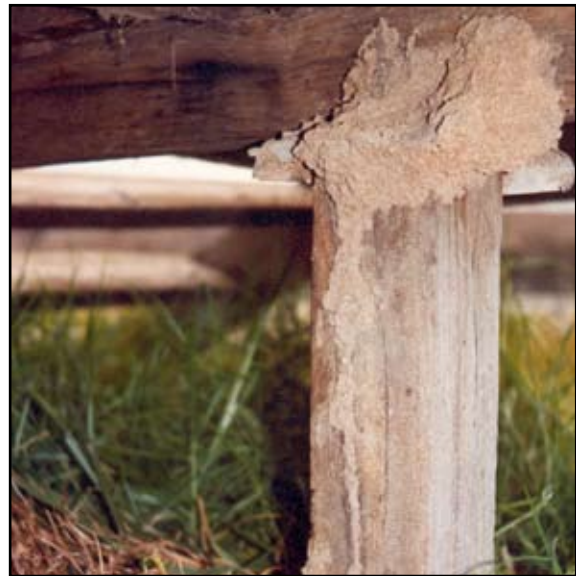
Termite attack on a stump

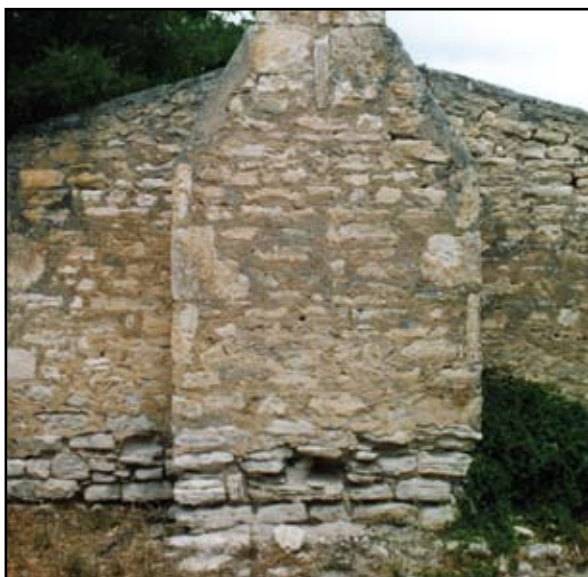
Typical case of rising damp due to lack of damp proof course.

Theoretically, controlling any one of these factors will arrest the decay. In practice, two of the factors are beyond practical influence - the **porosity** of the masonry is a quality inherent to the particular material, and **dissolved salts** are determined by the regional groundwater salinity.

The presence of **moisture** can be controlled by a number of means, including:

- introducing a damp course into the wall
- improving drainage of roof water and surface water away from the wall
- improving sub-floor ventilation
- keeping garden beds and sprinklers clear of the wall

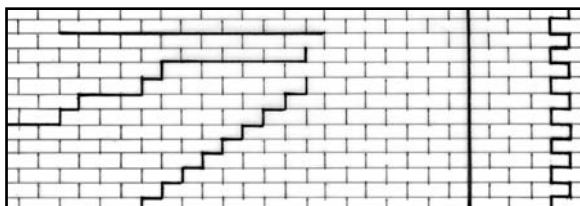
Types of Cracking – Cogged, Vertical, Horizontal and Stepped

Cracks in masonry walls appear when the stresses within the wall exceed the wall's ability to resist them. In the majority of cases, the cause of stress will be soil movement under the building due to one or more of the following actions:

- rusting of iron strapping built into brickwork - this appears as a long horizontal crack through a mortar joint line, and may occur at several different levels depending on the positions of the iron reinforcing straps
- lateral forces transferred from the roof framing - this may be a long-term problem of poor design, or may result from structural failure of some part of the roof structure
- overloading due to alterations and additions - where an old wall is required to provide structural support for new work, rather than the new wall being self-supporting.

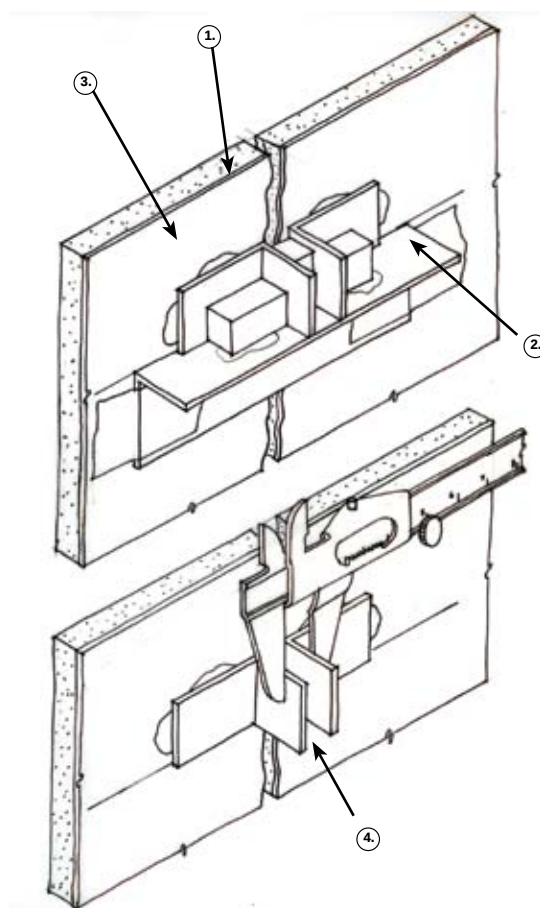
Tell-tale device

1. Crack tell-tale ex. – aluminium angle 20x30x2
2. Aluminium angle jig to hold tell-tales in place while epoxy glue sets.
3. Epoxy glue taped to wall surface
4. Tell-tales in place with jig removed – use vernier caliper to measure movement

A simple method of checking if a crack is moving is to mark a cross in pencil on either side of the crack in question. The crosses should be at right angles to the crack and about 100 millimetres either side. Accurately measure the distance between the crosses and record this distance. At regular intervals, say every two months, measure the distance again and record this with the previous results. If a straight line is drawn between the two crosses, any movement along the length of the crack can also be measured by noting the dislocation between the two halves of the line.

A more complete method involves the construction of a 'tell tale' as illustrated. This monitoring should be carried out for at least twelve months, and preferably two years, in order to obtain an
